**Bed Coil Tube Failures in AFBC Boiler
– It's not always Erosion!**

**Ansuman Sen Sharma
India Boiler dot Com**

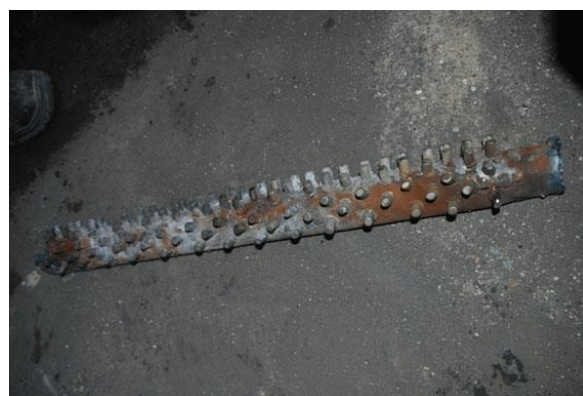
Photo 1: Failed Bed coil tube; Material Size & Specification: Ø 51 x 6.35 mm and SA 210 Gr. A1

The visual inspection revealed severe thinning at 12 O'clock position at the failed location with no indication of external metal wastage, which is normally found with bed coil erosion.

It looked like a classic case of Caustic Gouging and it was advised to take microstructure of the failed samples to confirm the same. Over loading along with lower drum level may have caused DNB, followed by film boiling condition. The phosphate was also kept on the lower side. Charcoal as start-up fuel also creates a sharp rise in bed temperature during start-up.

- Avoid operation with lower drum level.
- The maintenance team should thoroughly inspect the health of drum separators, especially the secondary screen separators and replace if found to be damaged.
- They should also explore the viability of installing external steam drier if they want to continue with overload operation.
- Increase the phosphate buffer to 5-6 ppm as required for their boiler.
- Check the nozzle health, straightness and health of the bottom plate to ensure even fluidization of bed.
- Replace the bed coil tubes with rifle bore tubes which might help to maintain a turbulent flow through the tubes and thus avoid DNB.

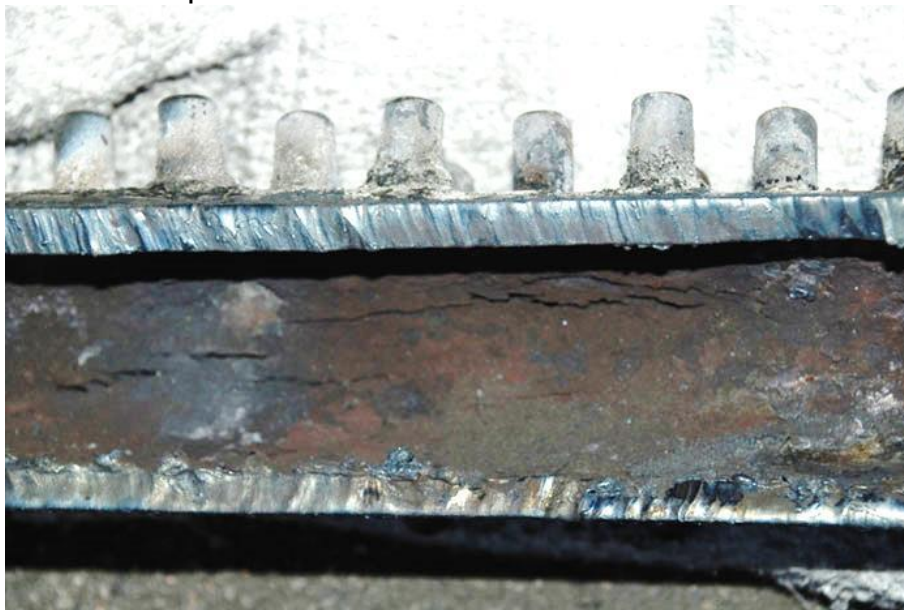
The failed parts of the tubes were cut into two halves and gouging damage could be seen at 12 O'clock position.

Photo2: showing the gouged part

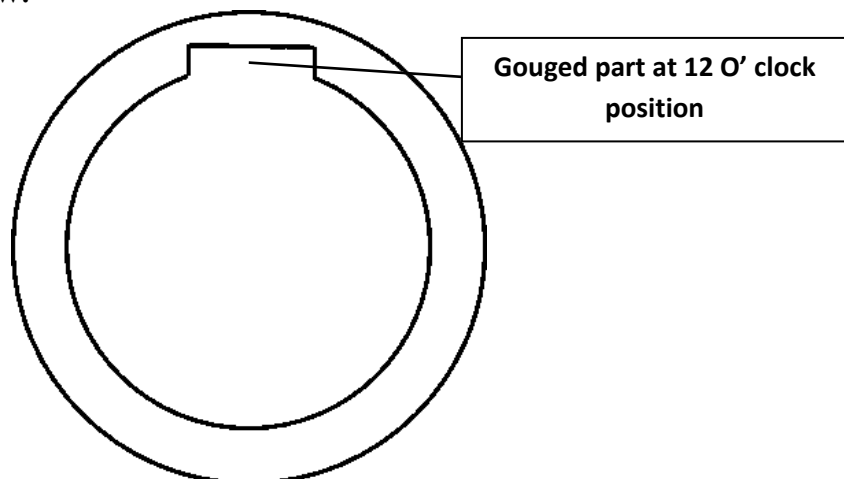
In some places, the metal was gouged out forming a groove with regular edges as shown in the figure below.

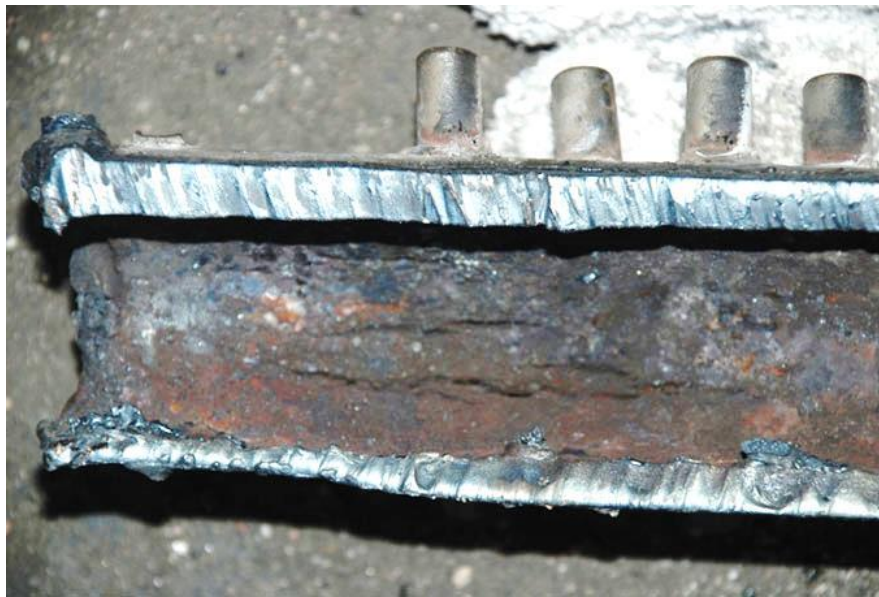
Around the gouged part at some places, whitish deposits could be seen. A swab analysis showed these deposits to be strongly basic (pH in excess of 11) in nature.

Photo 3: deposits around gouged section

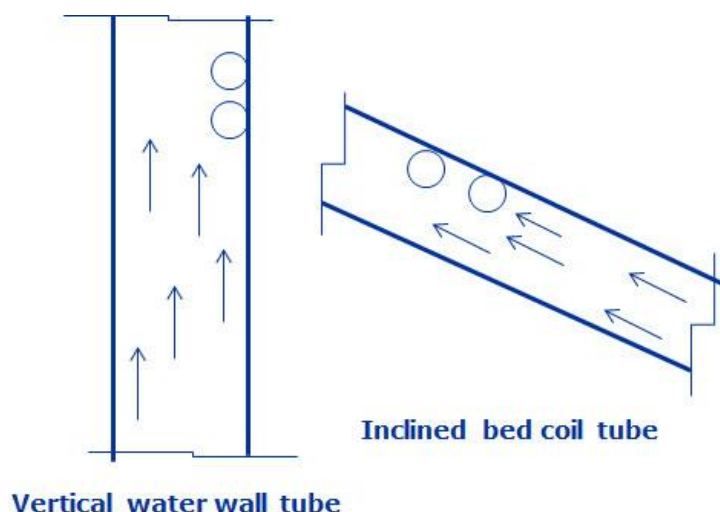
In the case I was referring, the plant was using charcoal as start-up fuel. When charcoal is used during cold start of the AFBC boilers, bed temperature shoots up to 500°C within 30-45 minutes. Since the natural circulation slowly establishes as the steam load increases during cold start, this sudden increase in heat load in the bed could lead to DNB (Departure from Nucleate Boiling) and formation of steam blanketing on the tube surface. The possibilities of DNB would be more in the inclined bed coil tubes as compared to vertical water wall tubes as the natural buoyant forces on the steam bubbles act perpendicular to the direction of the flow of water through these tubes (Refer Figure below).

The film boiling would take place in the 12 O' clock position in the bed coil tube as a result.
