**Bed Coil Tube Failures in AFBC Boiler
– It's not always Erosion!**

**Ansuman Sen Sharma
India Boiler dot Com**

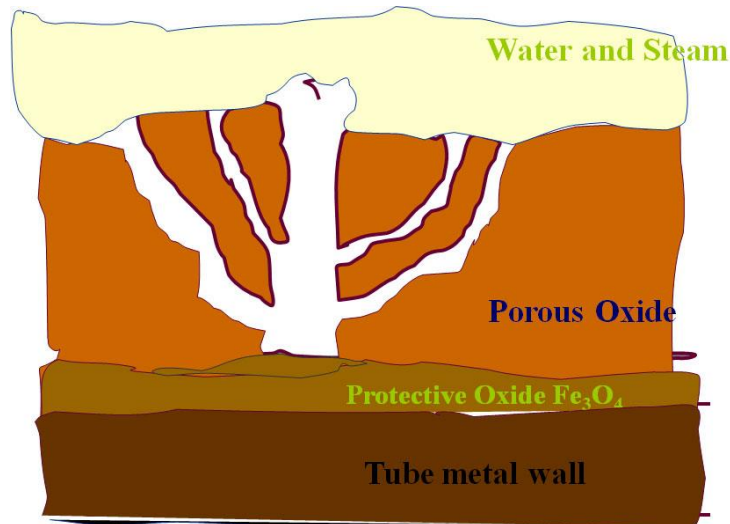
This may happen either below a porous metallic oxide deposit (**wick Boiling**), or below a Film Boiling condition.

The water present below a porous deposit slowly escapes through the micro-pores, which increases the concentration of various chemical parameters under the deposit. If the cation-anion is not balanced, the pH may either become very high or, very low. If it becomes highly basic, the caustic concentration will be high enough to cause caustic gouging.

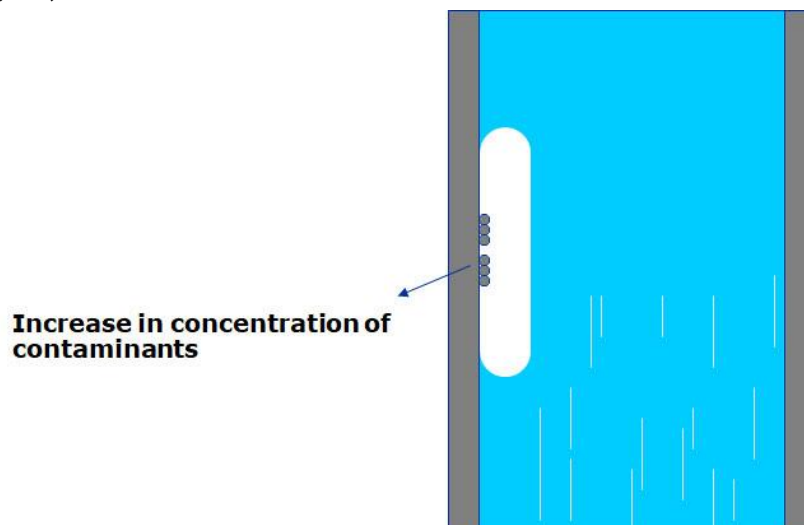
Similarly, the localized concentration would increase below a **film boiling** condition (figure below) that may form in the water wall tubes due to disturbance of circulation, or, excessive heat flux.

In natural circulation boilers, the drum level and controlled heat flux on the tubes plays a very important role to maintain nucleate boiling inside the water wall tubes. It becomes even more critical during the cold start, when the quantity of steam forming in the riser tubes is less and as a result the circulation is minimum.
